COMPOSITE TUBES IN BLACK LIQUOR RECOVERY BOILERS: AN UPDATE

Newly developed alloys help to resist corrosion

BY J.F. MCGURN

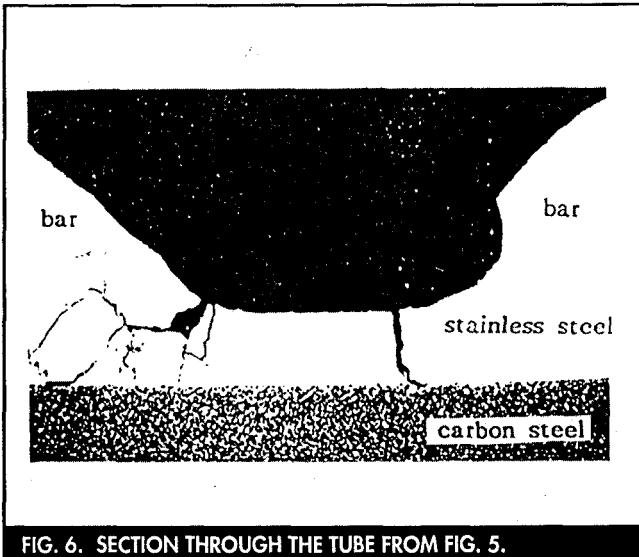
FIG. 6. SECTION THROUGH THE TUBE FROM FIG. 5.

The cracks did not enter the carbon steel, Fig. 6. Thermal fatigue and stress corrosion cracking were suspected as the cause of the cracks due to stresses from welding and bending of the tubes [2].

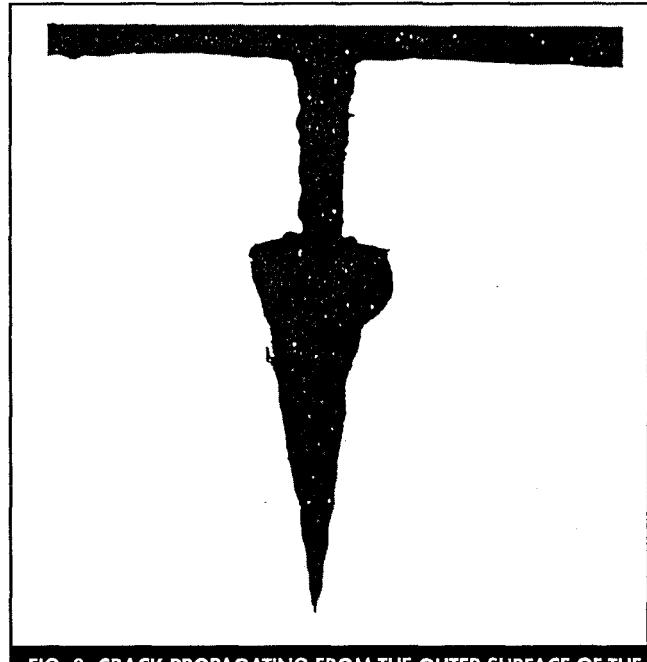
FIG. 8. CRACK PROPAGATING FROM THE OUTER SURFACE OF THE STAINLESS STEEL INTO THE CARBON STEEL.

Primary air ports: A Canadian boiler, after four years service, formed straight cracks in the composite tube with some of these going into the carbon steel, Fig. 8. One such crack penetrated the carbon steel. Inside the tube, a 1/16 in.-thick iron oxide deposit was found.

Metallurgical examination revealed the tube had experienced a temperature in the region of 500 - 550°C (930 - 1020°F) as determined by a change in the metal microstructure and the growth in the decarburized layer from its original 0.004 in. to 0.014 in.

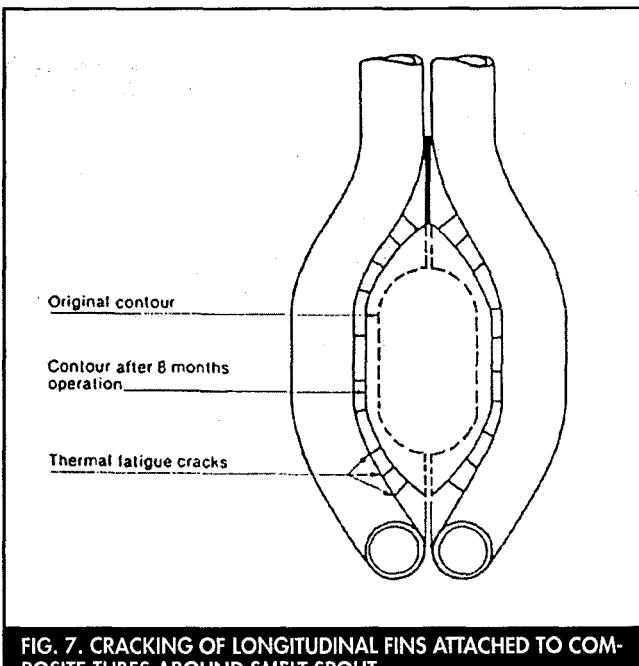
FIG. 7. CRACKING OF LONGITUDINAL FINS ATTACHED TO COMPOSITE TUBES AROUND SMELT SPOUT.

In the ASSI/Lovholmen boiler, longitudinal fins of stainless steel had been attached to composite tubes around smelt spouts, Fig. 7. These corroded with some penetration to the carbon steel. Examination revealed overheating and thermal fatigue as the causes of the problem.

New tubes without fins were installed and the spout was allowed to protrude a little into the boiler. This permitted smelt to freeze on the composite tubes and form a protective barrier which has extended the life of the tubes.

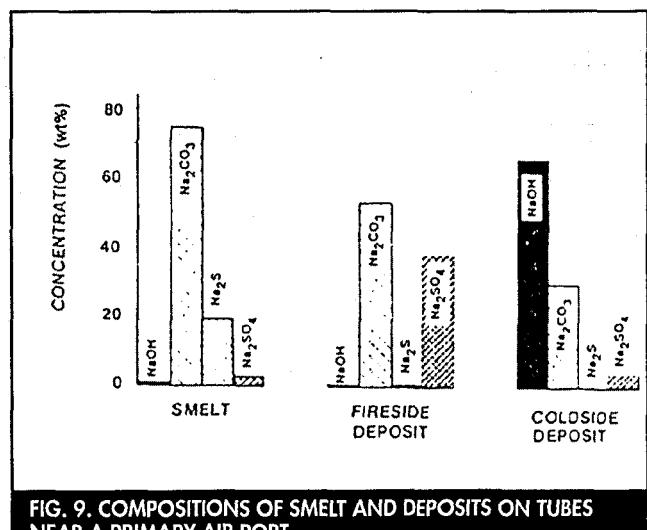
FIG. 9. COMPOSITIONS OF SMELT AND DEPOSITS ON TUBES NEAR A PRIMARY AIR PORT.

Such cold side corrosion is attributed to the presence of molten alkali (NaOH and KOH) in deposits at the tube surface. In a Scandinavian boiler the composition of the smelt and fireside deposit consisted of Na₂CO₃ and Na₂S or Na₂SO₄ with little or no NaOH. The fireside deposit indicated that it was simply an "oxidized" smelt.

Alternatively, the coldside deposit had a large amount of NaOH with small amounts of Na₂SO₄ and no Na₂S which suggests these chemicals were not formed by the same mechanism as the fireside deposit. Compositions of these deposits are revealed in Fig. 9.

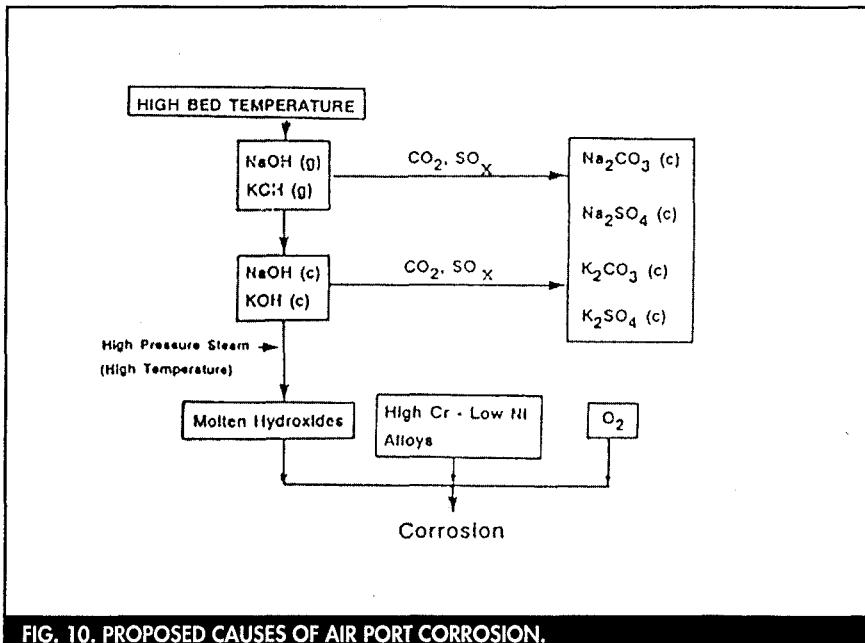
FIG. 10. PROPOSED CAUSES OF AIR PORT CORROSION.

Figure 10 proposes the formation mechanism. Here, sodium and phosphorous vaporize from the high temperature smelt bed to form gaseous hydroxides when reacting with H₂O. These

diffuse with the flue gas going behind the air port and upon cooling a little, condense on the tubes forming hydroxide-rich deposit. The deposits age and react with CO_2 and SO_x in flue gases to form carbonates and sulphates which are solid and harmless.

In the gas atmosphere where CO_2 and SO_3 concentrations are low, close to air ports, alkali hydroxides remain unchanged in deposits. These likely melt in high temperature boilers forming alkali hydroxides which react with the protective Cr_2O_3 on the Type 304L

cladding under oxidizing conditions at air ports to form alkali chromates.

- Seal all areas to prevent the backward flow of gases at air ports;
- Where corrosion has occurred, carry out weld overlay repair with alloy 600

(SANICRO 71 or 72);

- Consider the use of alloy 825 co-extruded on SA-210 Gr.A1 where seals cannot be accomplished or where weld overlay cannot be carried out.
