Navy Divers

Complete Critical Repairs to Chinese Vessel

Emergency Response Prevents Major Fuel Spill

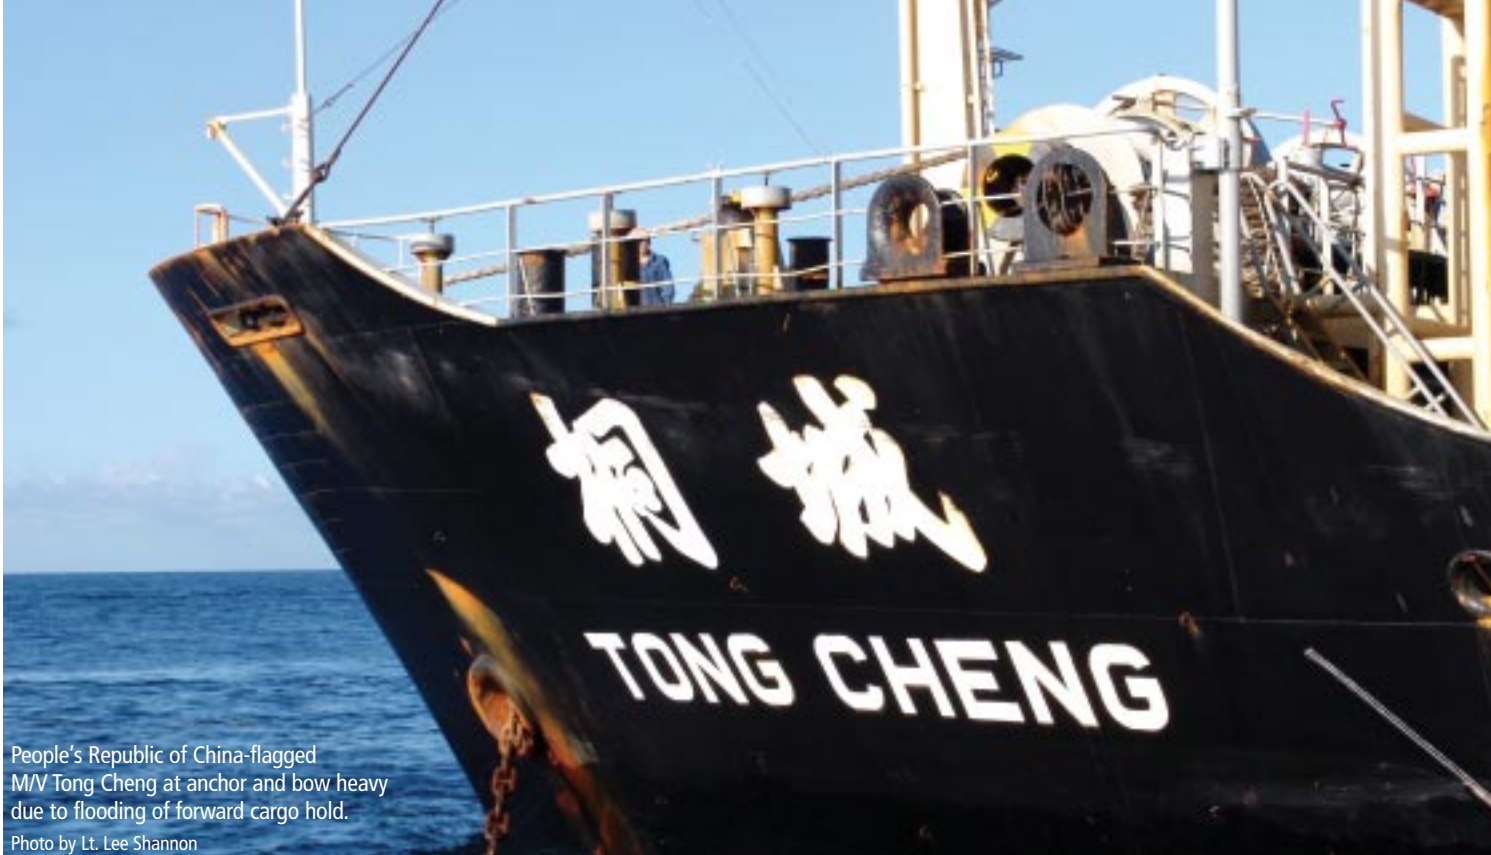
People's Republic of China-flagged M/V Tong Cheng at anchor and bow heavy due to flooding of forward cargo hold.

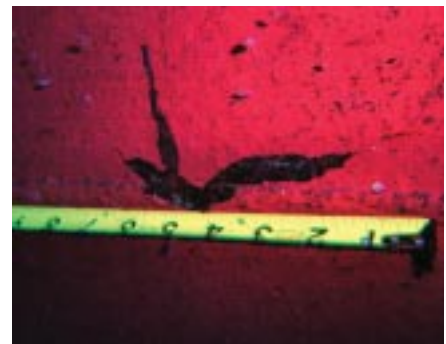
Navy divers completed an open ocean, underwater hull survey on the ship that rose and fell with the constant wave action. Divers located the 1/8-inch wide crack 30 feet below the water line, which had extended from 29-inches long to 56-inches long. They discovered two additional 6-inch “L” shaped cracks that were spreading. Deatruck’s team captured underwater video and still photos that were forwarded to the ICC to fill in infor-

One of three cracks discovered during MDSU 1 Detachment 9's at-sea underwater hull survey and damage assessment of the M/V Tong Cheng.

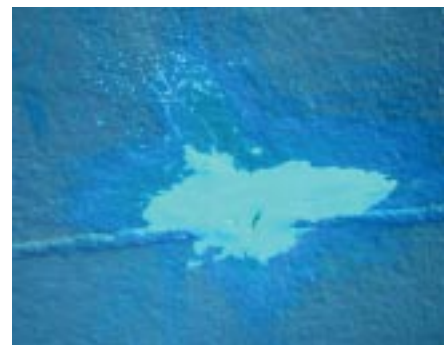
Temporary repairs conducted by the MDSU 1 scuba team. Waterproof epoxy was used to fill the cracks and control the flooding prior to surface supplied diving and pumping operations once the vessel was moved close to shore.

The next day, with the weather window for diving operations closing, Tong Cheng again went DIW and Navy scuba divers installed the temporary patches, which required a four- to six-hour cure time. The integrity of the patch could not be confirmed until dewatering began and the water level in the cargo hold dropped.

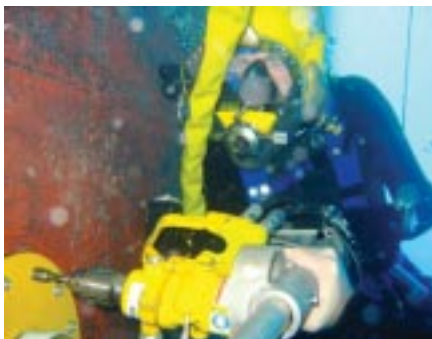
A Navy diver from MDSU 1 installs self tapping screws using an underwater hydraulic impact wrench while installing a hot tap flange on the M/V Tong Cheng.
Photo by Navy Diver 1st Class Jason Mette

supplied dive team that embarked an ocean barge and completed the staggered installation of hot taps at 14, 21, and 28 feet below the water line.

Hot tapping is a procedure used to remove liquid loads from sunken vessels that are inaccessible by normal pumping means, explained Navy Diver 2nd Class Shawan Gerasimchik, who assisted in the hot tap installation. The procedure involves using a hole saw to cut 4-inch diameter holes in which ball valves are installed. The valves are connected to suction hoses and pumps that remove liquid from tanks.
