Navy Divers

Complete Critical Repairs to Chinese Vessel

Emergency Response Prevents Major Fuel Spill

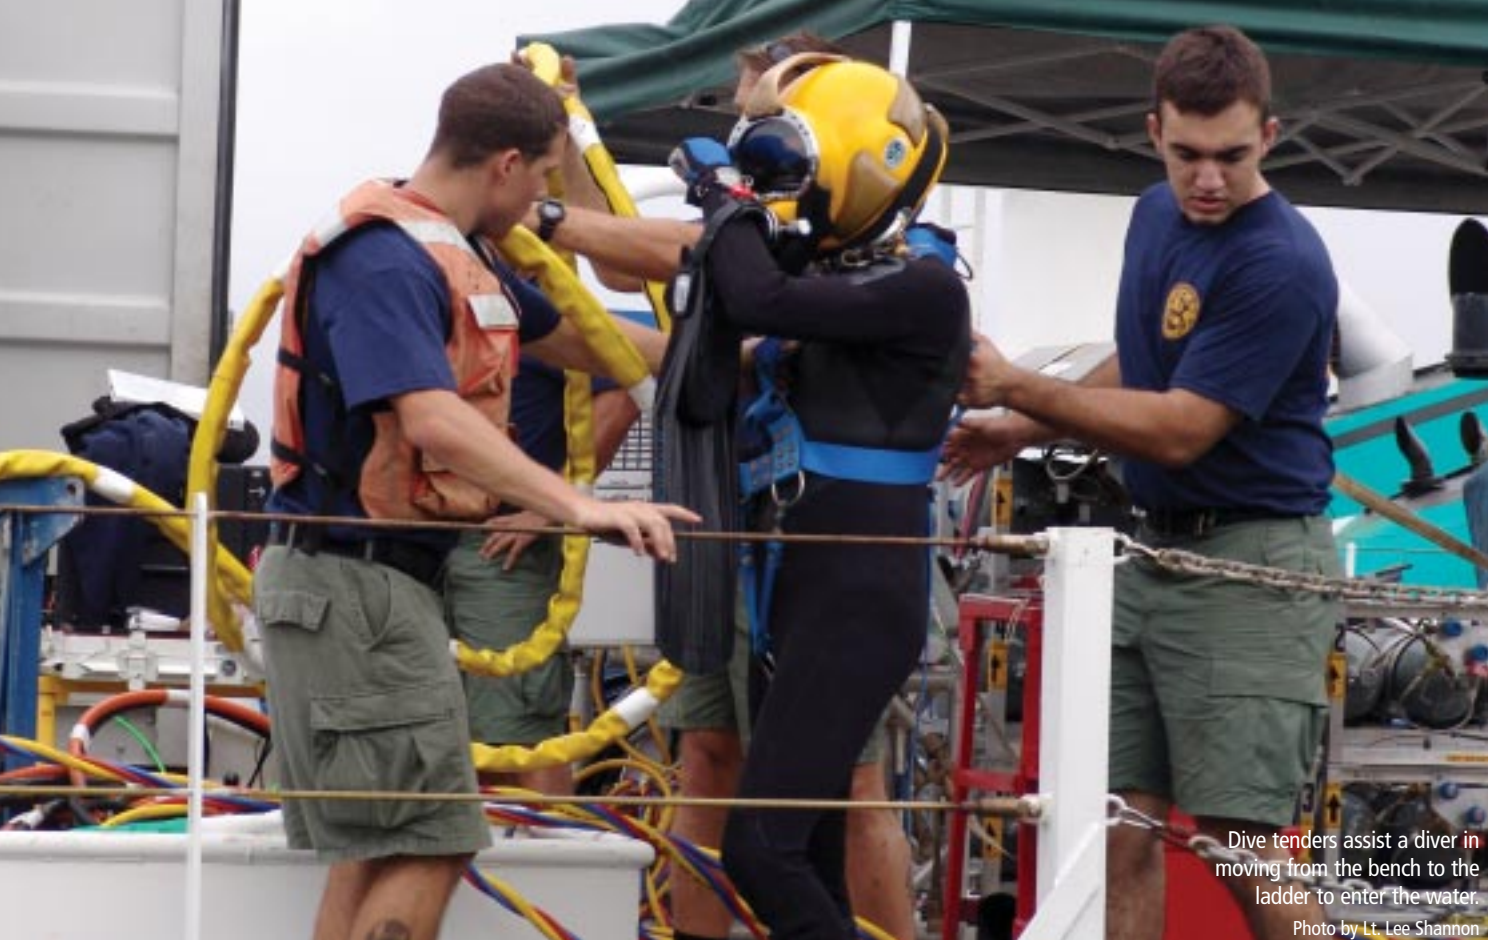
Temporary repairs conducted by the MDSU 1 scuba team. Waterproof epoxy was used to fill the cracks and control the flooding prior to surface supplied diving and pumping operations once the vessel was moved close to shore.
