What Side of the Meter Are You On?

Proactively Looking and Listening for Leaks on Pipes and Aqueducts

**2010 Watersmart Innovations
Conference & Exposition**

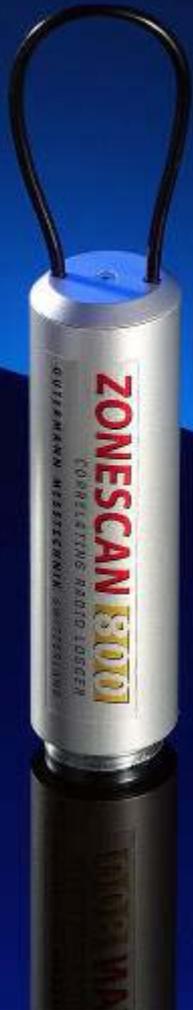
How does a logger work?

- Magnetically attaches to valve pots
- Records sounds every 5 seconds (2-4 a.m; 2 hours = 1,440 reads daily)
- Based on distribution of leak sounds determines leak index from 0-100
- Loggers store leak numbers and graphical data
- Data recovered by a 2-way receiver
- Leak status announced on drive-by

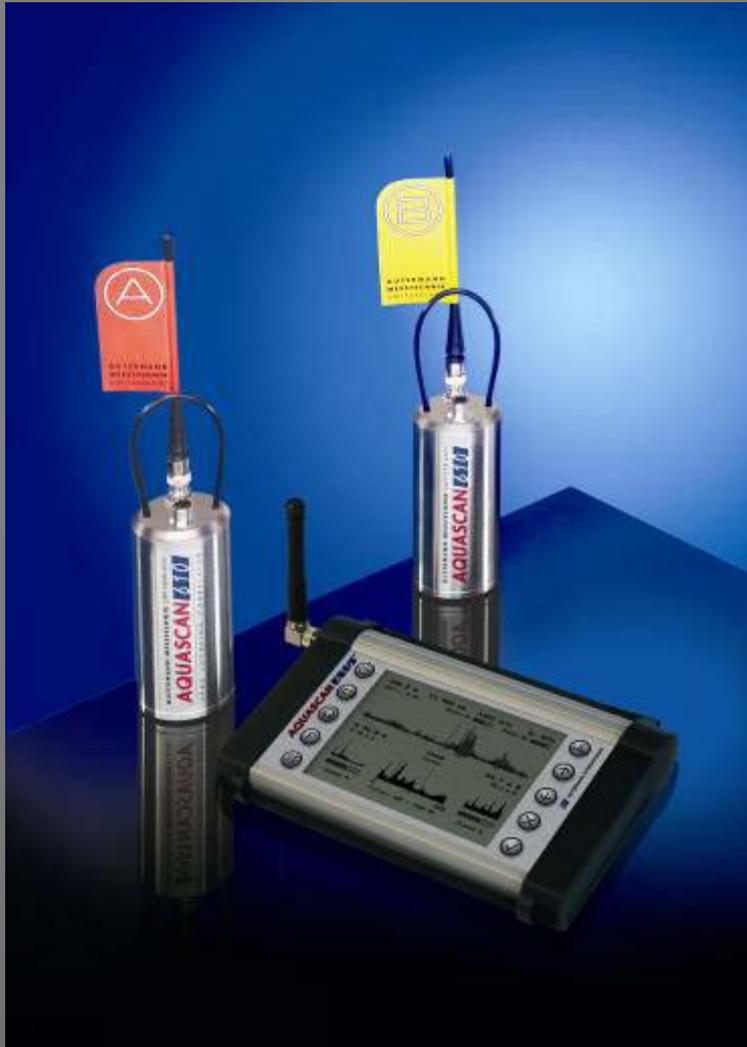
How does a correlator work?

- Compares the sounds heard at 2 stations on either side of a leak
- Uses the sound velocity multiplied by time lag to calculate distance
- Sound velocity dependent on pipe:
 - Diameter
 - Material
 - Wall thickness
 - Pressure/Temperature-minor effects

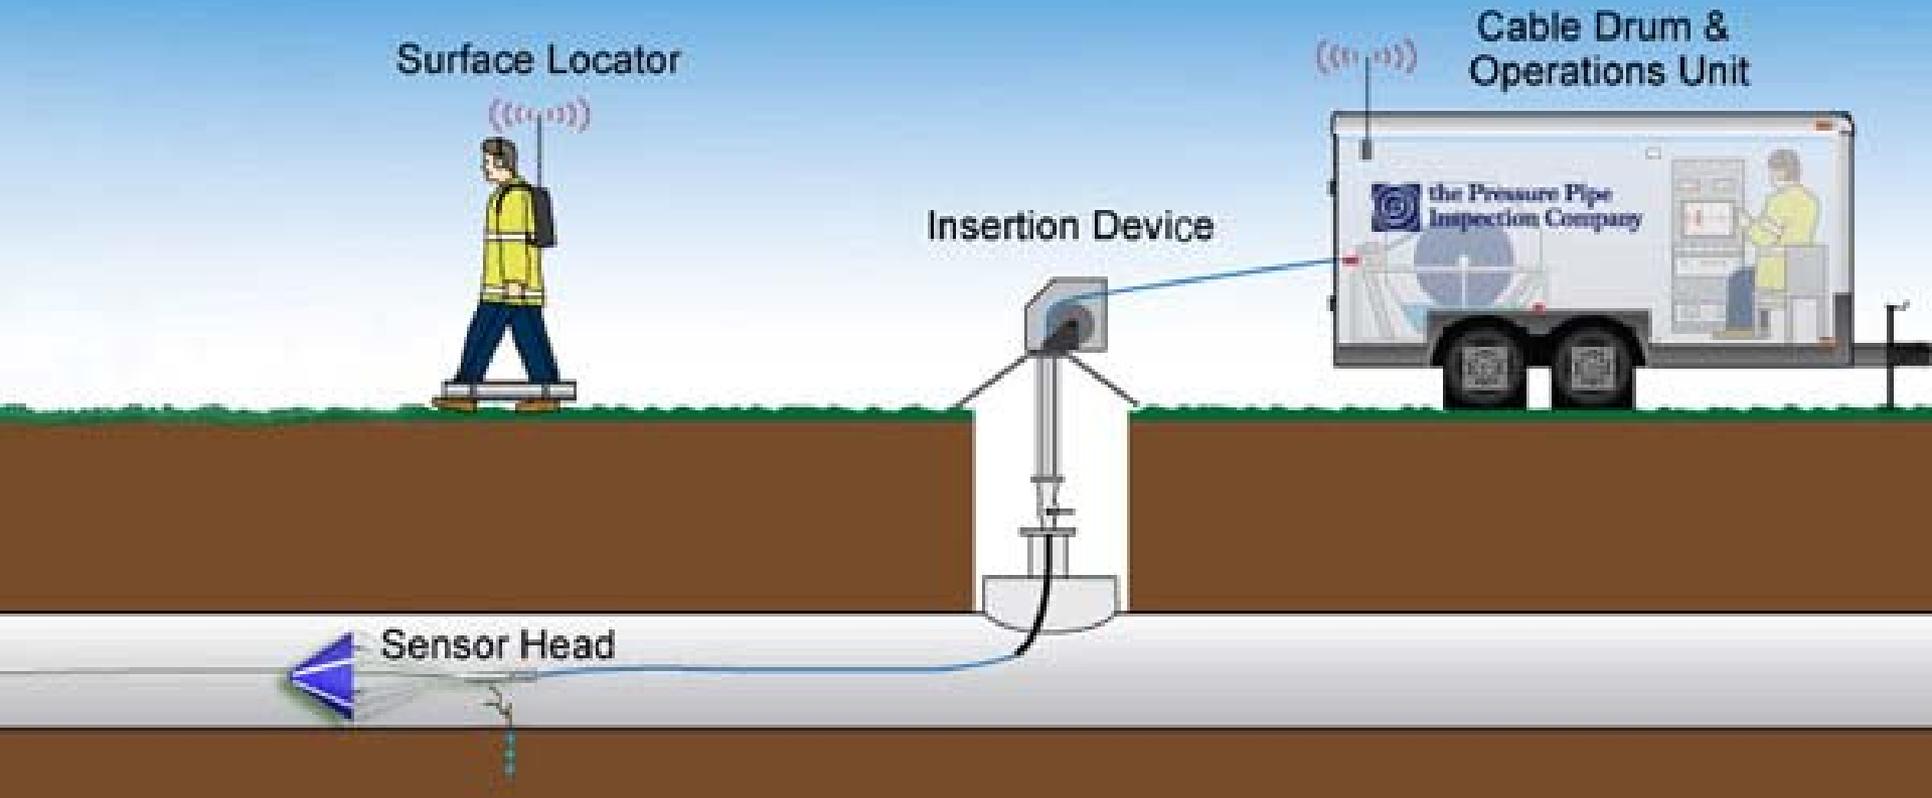
PPIC "SAHARA" Acoustic System

- Pressure Pipe Inspection Company "SAHARA" System
 - Tethered acoustic sensor drawn by parachute
 - Capability to 5,000 feet/run or 270 degrees of bends
- Pure Technologies U.S. Ltd. "Smart Ball"
 - Free-rolling Ball (not tethered)
 - Capable of 12-15 hours at about 90% of water velocity (>1 ft/s)
 - Can pass through "some" obstructions
- Echologics Engineering "Leakfinder RT"
 - Acoustic and auto correlation functions
 - Capable of 300-5,000 foot spans in steel pipe

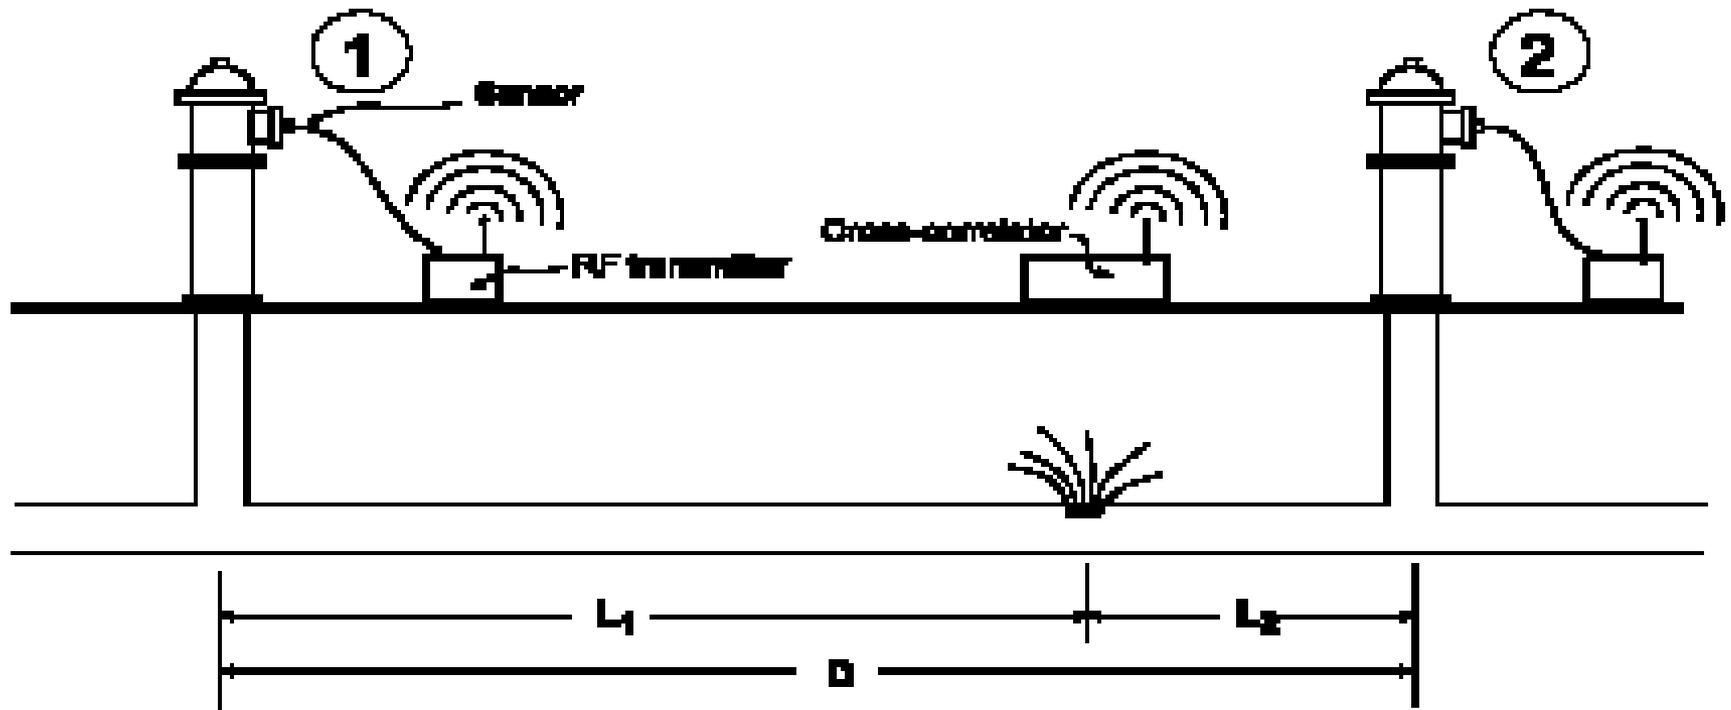
Figure 1 Schematic illustration of the cross-correlation method
